## Preliminary Analysis of Slope Stability in Kuok and Surrounding Areas

### Abstract

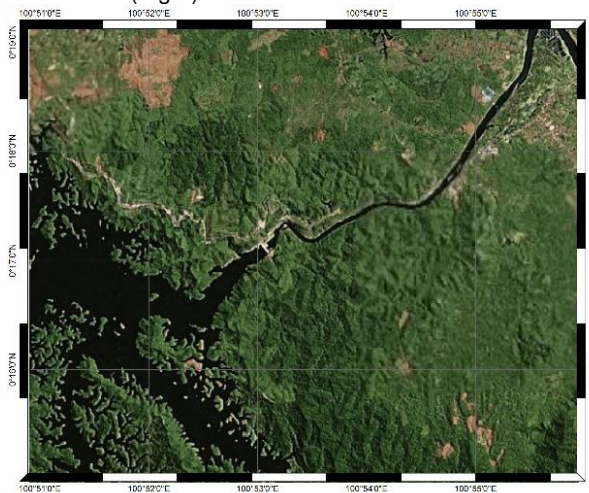
Fig 2. Topography map of research area

Kuok and the surrounding area are composed by several formations and geological structures which formed the topography at recent time (Figure 2). Based on the Geological Map of Pekanbaru [12] suggested that formation on the research area consist of Bohorok Formation (Pub) consist of Wacke, conglomeratic wacke and turbidite deposit; then also at the same age deposited Member of Tanjung Pauh (Pukt) of the Tapanuli Group that consist of muscovit chlorit cabonate schist with strong lineation. Then an intrusion of Granite Pulaugadang triad (MPipg), consist of strong foliation of granite gneiss. On the northeast side, Pematang Formation was deposited containing red and mottled mudstone, breccio-conglomerates and conglomeratic sandstones. After that Shapas Formations (Tms) deposited on miocene which contains the conglomerate sandstone, and siltstone. The youngest formation on research area is Petani Formation (Tup) consisting of mudstone, carbonaceous, lignite, slightly siltstone and sandstone. (Fig 3).

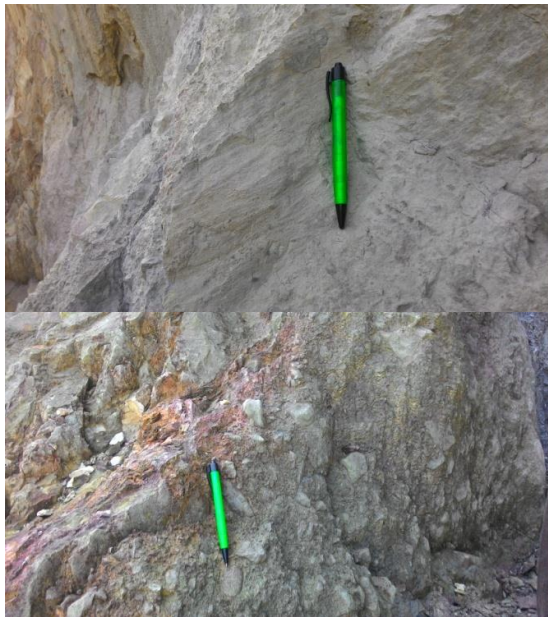
Fig 5. Fault breccias and slicken side feature indicating the slope was affected by a fault system.

A slope stability analysis had been assessed to the cut slope. The slope was considered as heavily jointed slope due to a fault system that developed in the site (Fig 5).
